## PREDICTING SOUND INSULATION PERFORMANCE

USING SOUND INSULATION SOFTWARE TO PREDICT NON-ACHIEVEMENT OF PERFORMANCE STANDARDS (CRITERIA). PRESENTED AT THE NEW ZEALAND ACOUSTICAL SOCIETY CONFERENCE 2002

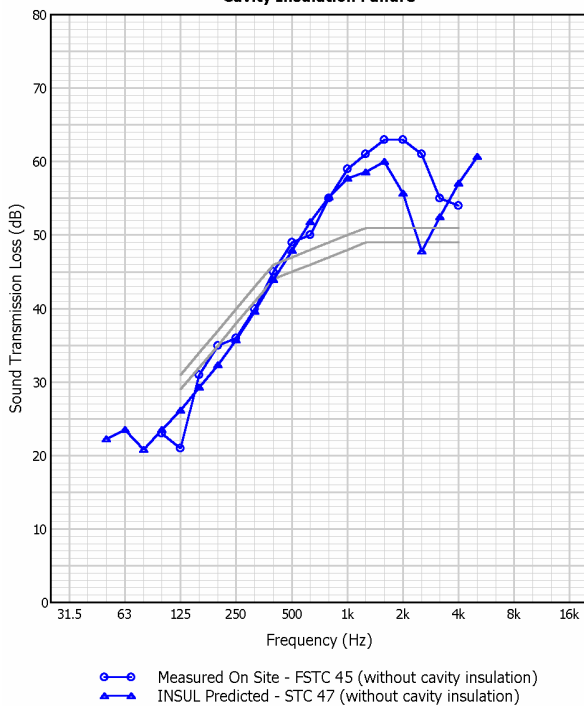
**Figure 1A: Single Stud Resilient Rail Wall**  
Gib GBT(L)A 90r - STC 55  
Cavity Insulation Failure

A Winstone Gib GBT(L)A 90r STC 55 wall (refer Table 1) was specified for the IT walls in an apartment complex. However, when on-site compliance measurements were carried out the results were typically FSTC 45, as shown in Figure 1A.

SIPS was used to predict the performance for this wall construction, without cavity insulation. A prediction of STC 47 and the shape of the transmission loss (TL) curve closely approximate that of the on-site failure curve (refer Figure 1A).

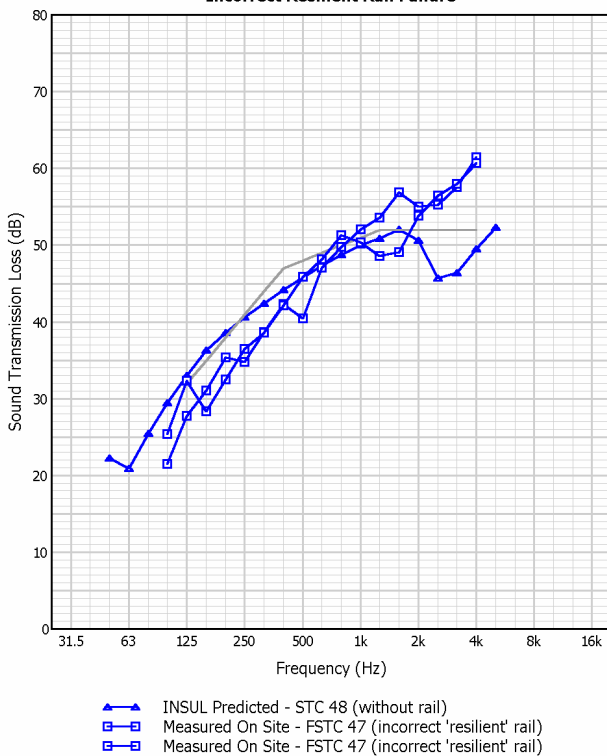
**Figure 2A: Single Stud Resilient Rail Wall**  
Gib GBT(L)A 60 - STC 55  
Incorrect Resilient Rail Failure

A Winstone Gib GBT(L)A 60a (refer Table 1) with measured performance of STC 55, was specified for an apartment project which however resulted in on-site failure due to substitution of a non-conforming resilient rail.

In Figure 2A, the measured on-site performance of two walls are shown with a measured sound insulation performance of FSTC 47. This rating falls short of the minimum NZ Building Code criterion (FSTC 50). Also, shown in Figure 2A is the SIPS prediction (STC 48) for the same wall construction without a resilient rail. The shape of the on-site and predicted TL curves closely approximate each other between 100 and 2,000 Hz.

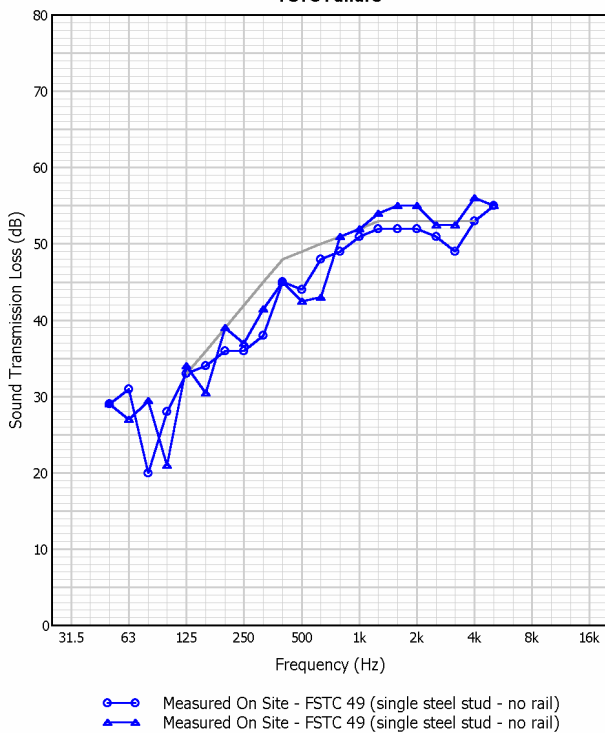
**Figure 3A: Single Steel Stud Wall**  
EP EBSA60b - STC 56  
FSTC Failure

For this particular apartment complex Elephant Plasterboards EPSA60b with a measured performance of STC 56 were used for the construction of the IT walls (refer Table 1). On-site measurements revealed performances of typically FSTC 49.

The measured on-site results are shown for two walls in Figure 3A. The measured on-site result is also repeated in Figure 3B along with the SIPS rating for this construction, STC 55. A possible solution to meet the NZ Building Code is the provision of an additional sheet to one side of the partition on-site (SIPS predicted STC 58).

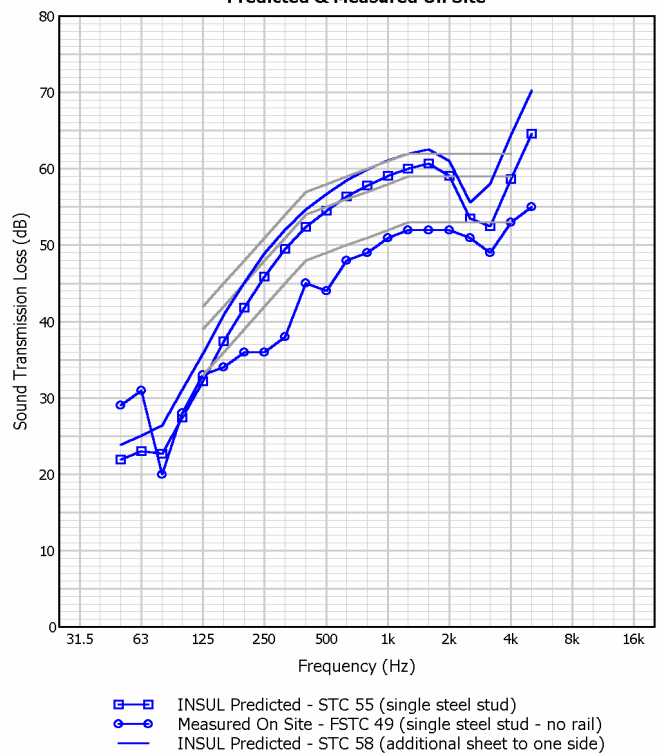
**Figure 3B: Single Steel Stud Wall**  
EP EBSA60b - STC 56  
Predicted & Measured On Site

From a number of tests of single stud partitions, both within the laboratory and on-site, allowing for the vagaries of flanking transmission and construction techniques indicates that resilient rails are required on single stud walls in order to meet the minimum criterion. SIPS also predict STC 55 for this Elephant Plasterboard wall construction. However the SIPS is a prediction tool and, as noted above, complying and maintaining the on-site minimum performance criterion is very difficult without the inclusion of resilient rails. The frequency range in which the resilient rail is performing in conjunction with a single stud wall is clearly shown in Figure 4A and corresponds to the test frequency range for on-site testing.

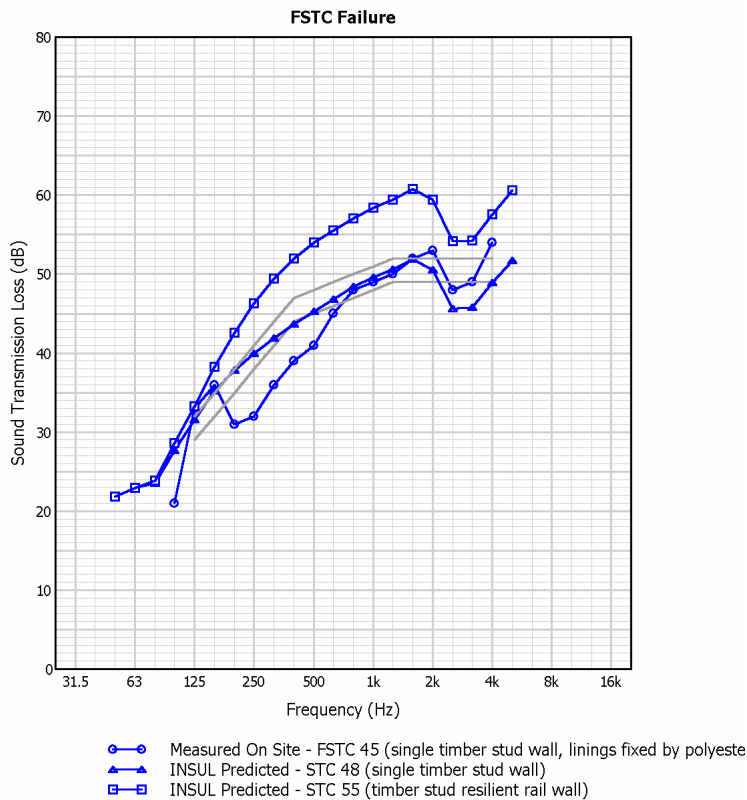
**Figure 4A: Single Timber Stud Wall - Linings Fixed Through Polyester Strip**  
**CTS TGLA60p - STC 55**

For this apartment complex the builder had recommended as an alternative to the specified resilient rail STC 55 wall the use of a CTS Plasterboard Products type TGLA60p wall construction which has a documented rating of STC 55. As described in Table 1 the wall linings are connected to the studs through Polyester strips.

The measured on-site performance of FSTC 45 for this wall construction is shown in Figure 4A. Also, in Figure 4A is the SIPS rating for this wall of STC 48 based on the wall linings directly fixed to the timber stud. There is very close agreement between the predicted and on-site TL's, except for a notable reduction around 250 Hz for the on-site performance, most likely due to some form of resonance.

The same wall construction with resilient rails replacing the polyester strips is shown in Figure 4A with a predicted rating of STC 55. For this apartment complex the originally specified walls with resilient rails were installed.

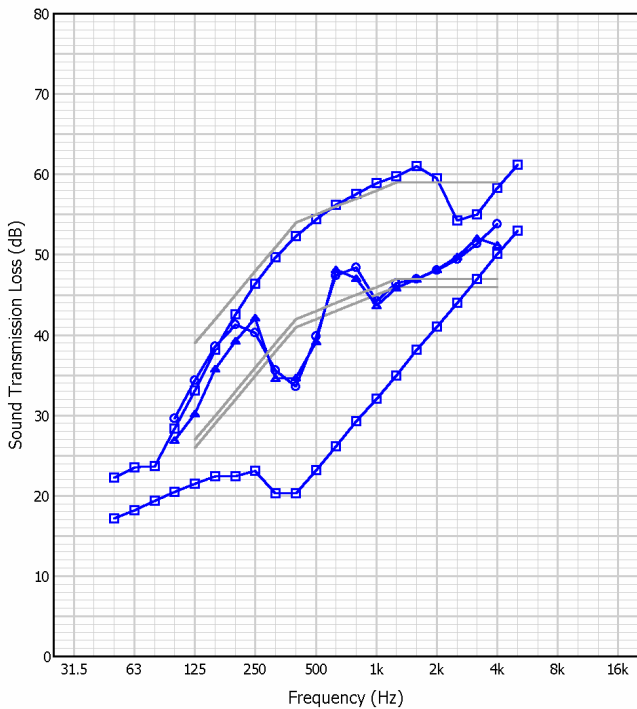
**Figure 5A: Steel Stud Resilient Rail Wall  
Gib GBSA60a - STC 55  
FSTC Failure Due To Continuous Floor**

In New Zealand there are a large number of buildings that are being refurbished where the floors, typically timber, are being maintained and refurbished. The inherent problem of continuous floors on the sound insulation performance of wall systems is well known and documented, and despite this a number of apartments are still being constructed on continuous floors. On a recent project a Winstone Gib GBSA60 wall (refer Table 1 and Figure 5A) with a measured performance of STC 55 was installed in a refurbished apartment building.

The measured on-site results as described in Figure 5A, revealed significant non-compliance with the NZ Building Code criterion where results of FSTC 42 and FSTC 43 were obtained. The shape of the on-site sound transmission loss curve indicated a significant dip in the curve occurring at 400 Hz. The existing flooring, a 35 mm thick tongue and groove timber was modelled in the SIPS and its TL curve is also shown in Figure 5A. The coincidence dip for this flooring system coincided with those for the measured results on-site.

- INSUL Predicted - STC 55 (GBSA60a)
- Measured On Site - FSTC 42 (continuous 35 mm thick timber floor - bare)
- ▲—▲ Measured On Site - FSTC 43 (continuous 35 mm thick timber floor - carpet)
- INSUL Predicted - STC 29 (35 mm thick timber)

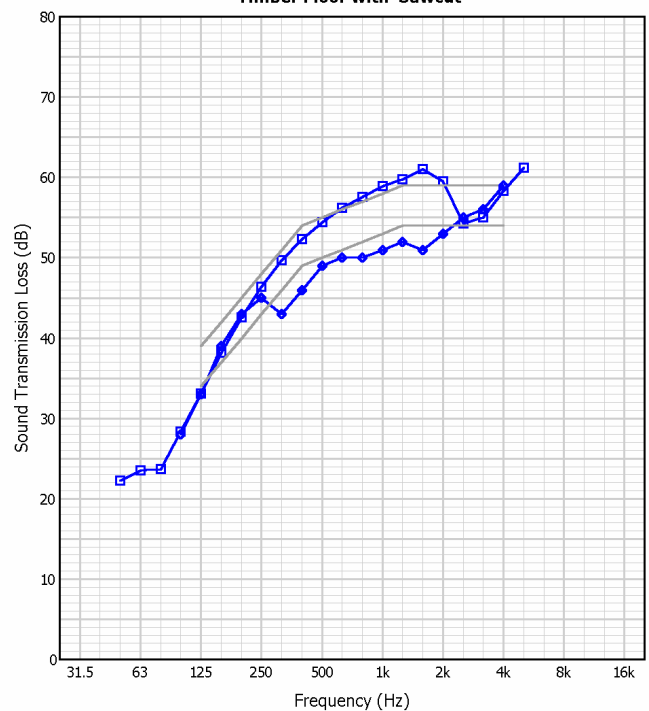
**Figure 5B: Steel Stud Resilient Rail Wall  
Gib GBSA60a - STC 55  
Timber Floor with 'Sawcut'**

- INSUL Predicted - STC 55 (GBSA60a)
- Measured on site - FSTC 51 (sawcut placed in 35 mm timber floor)

Following rectification works, where a saw cut was placed in the timber floor directly below the resilient rail, and in accordance with typical Winstone junction details, the wall was re-measured and an on-site performance of FSTC 51 was achieved. The results of this test and the SIPS performance of STC 55 for the Gib GBSA 60a wall are shown in Figure 5B.

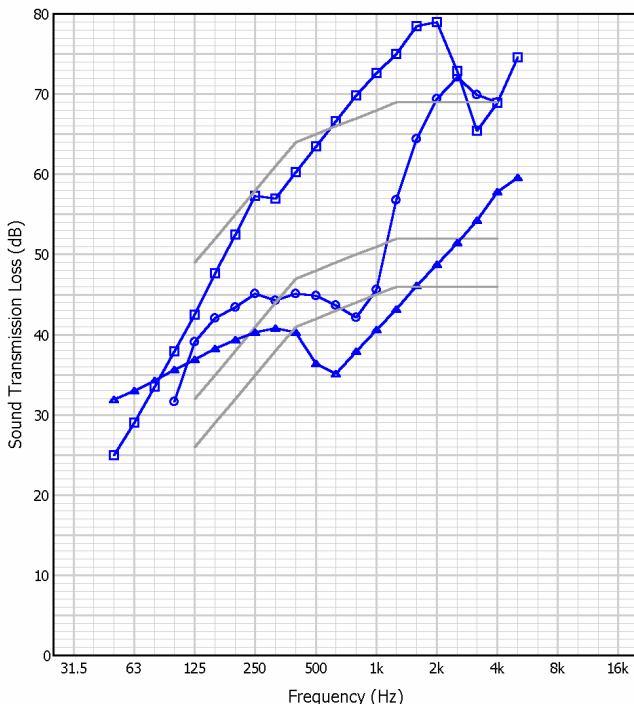
**Figure 6A: Double Timber Stud**

A wall similar to Winstone Gib GBT(L)A 30b was specified and constructed in an apartment block where higher criteria than that proposed in the NZ Building Code was specified. The wall construction was similar to that of the Winstone Gib GBT(L)A 30b (refer Table 1) with an additional layer of 13 mm Gib Toughline attached to the side with one layer of 10 mm Noiseline. The measured performance of the above Winstone double timber stud wall is STC 58 and with the additional layer of 13 mm Gib Toughline the SIPS rating is STC 65 as described and shown in Figures 6A and 6B.

Following on-site compliance testing of the above wall constructions, several walls indicated very poor performances of typically FSTC 48, when on-site results of FSTC 58 or better were expected.

There is a propensity in New Zealand to use thin structural slab floor systems such as Stahlton concrete floors and Dycore with 'hit and miss' infills, to reduce building costs. With respect to vertical noise separation these types of flooring systems have potential acoustic sound insulation and impact deficiencies that need to be designed for. They can also have detrimental horizontal flanking performances as is described below.

In the case of an apartment complex a Stahlton flooring system was used where, between concrete beams or ribs, timber support infill panels were used on which a concrete topping was poured. In some cases this concrete topping can be quite thin (e.g. 60 to 75 mm thick). Figure 6A shows the SIPS predicted performance for a 60 mm thick concrete floor which has a noticeable coincidence dip in its sound transmission loss at 630 Hz. The shape of 60 mm thick concrete floor sound transmission loss curve below and above this coincidence frequency dip closely approximates that of the measured on-site performance of the failed wall system. Follow up vibration measurements on the floor, wall and adjacent perimeter walls and ceiling confirmed that the concrete floor was the controlling noise transmission path in this instance. Figure 6B describes the results for the same wall construction that was located over a concrete beam, which achieved a rating of FSTC 56. The sound transmission loss curve for this on-site result above 250 Hz appears to follow the SIPS performance curve for the wall construction. Also shown in Figure 6B is the SIPS predicted rating of STC 52 for a 125 mm thick concrete floor and, again, this appears to closely approximate that TL curve for the on-site FSTC 56 floor.

**FSTC Failure Due To Continuous Concrete Floor**

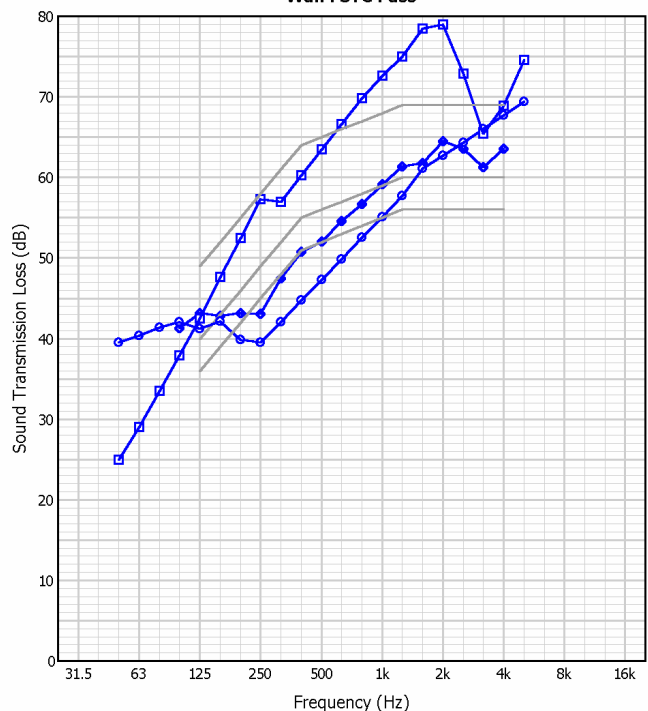
**Figure 6B: Double Timber Stud**

**Wall FSTC Pass**

- Measured on site - FSTC 56 (wall located on thick concrete floor)
- INSUL Predicted - STC 52 (125 mm thick concrete floor)
- INSUL Predicted - STC 65 (Wall)

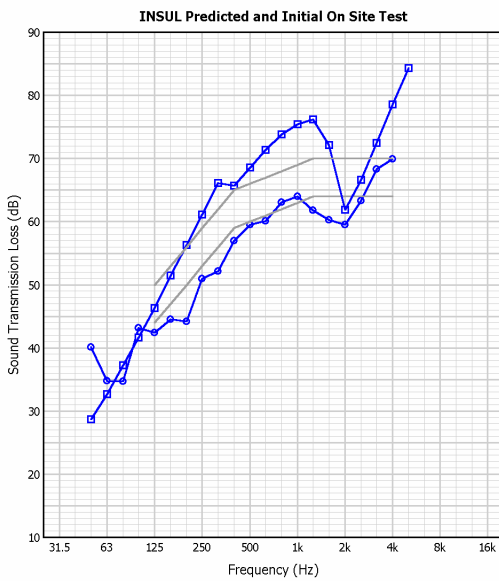
**Figure 7A: Double Steel Stud  
EP EBSA60b - STC 66**

To achieve an FSTC 58 performance in an apartment project the client specified a wall with a rating of at least STC 65. The builder for this project proposed an Elephant Plasterboard EBSA60b STC 66 rated wall as described in Table 1. The SIPS prediction for this wall construction is STC 66 and is described in Figure 7A. The first wall construction was tested on-site and a favourable measured result of FSTC 60 was obtained as described in Figure 7A.

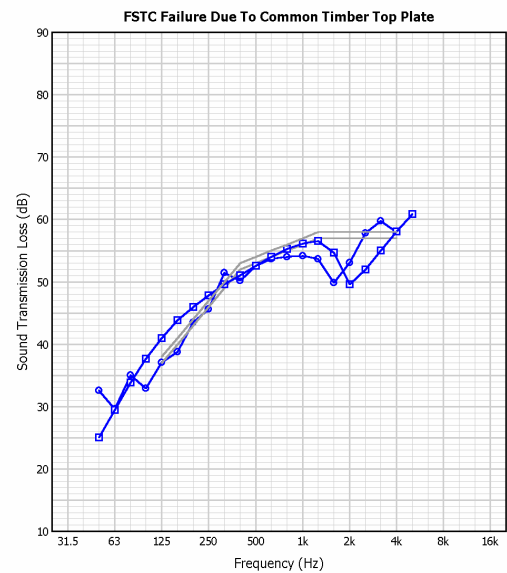
**Figure 7B: Double Steel Stud  
EP EBSA60b - STC 66**

As the building works progressed further on-site tests were carried out and typical results of around FSTC 53 to 54 were obtained and are described in Figure 7B. The SIPS predicted rating for this modelled wall, FSTC 54, is also shown in Figure 7B. The construction modelled is based on the double steel stud wall being connected by a common timber top plate (i.e. a 150 x 25 mm timber plate that was in turn directly fixed to a major steel beam). The sound transmission loss curves for the on-site measured levels and the SIPS predictions appear to mirror each other throughout the test spectrum range except for a slight octave difference in the coincidence frequencies. Another on-site measurement (FSTC 52) of a wall which had a common top plate and some high frequency leakage is shown in Figure 7C. Following a rebuild of this wall, which involved the separation of the common timber plate and sealing the wall perimeter, a very satisfactory on-site result of FSTC 59 was achieved. These results are described in Figure 7C.

—○— Measured On Site - FSTC 53 (common timber top plate)  
—□— INSUL Predicted - STC 54 (common timber top plate)

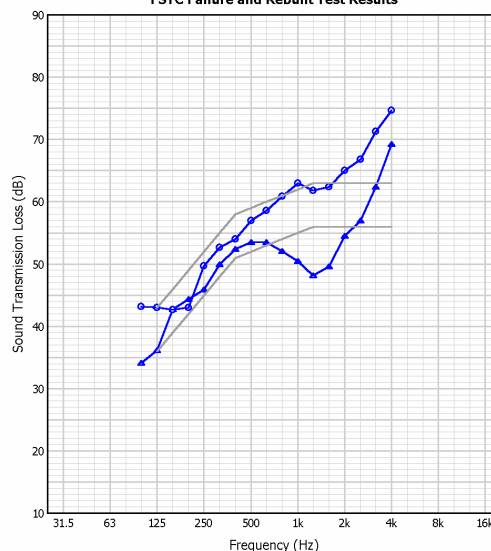
**Figure 7C: Double Steel Stud  
EP EBSA60b - STC 66**

**FSTC Failure and Rebuilt Test Results**

—▲— Measured On Site - FSTC 52 (common top plate and leak)  
—○— Measured On Site - FSTC 59 (wall rebuilt)

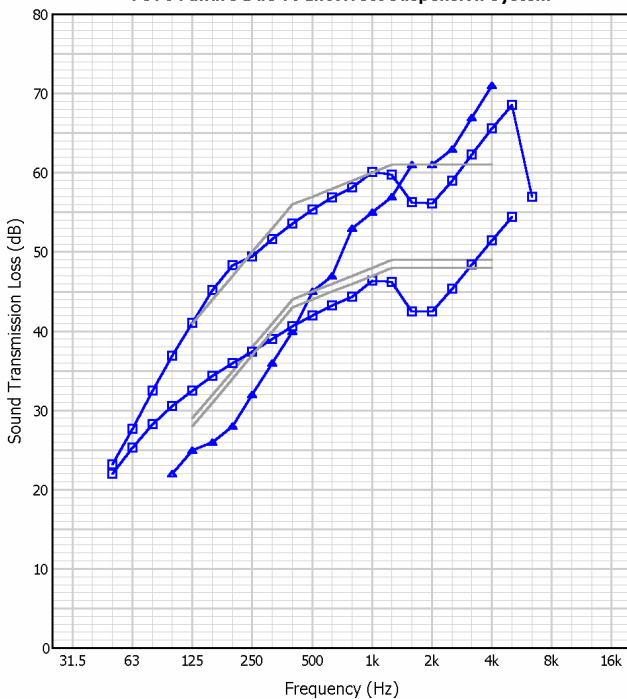
**Figure 8A: Timber Floor and Ceiling  
Gib GBSCA 60a - STC 58**

On a project where a Winstone Gib GBSCA 60a timber floor and ceiling system was specified (refer Table 1), the on-site results indicated a major failure of the construction.

The on-site result of FSTC 45 revealed a significant problem and non-conformance with the minimum Building Code criterion. The results are described in Figure 8A, including those for the SIPS prediction of the wall performance. Also shown in Figure 8A is the prediction of the same wall with the ceiling linings hard connected to the floor joists. The SIPS prediction is not as satisfactory as one would like and can be explained by the fact that:

- the ceiling suspension system used is not an equivalent or equal to that recommended by Gib, and,
- there is a major resonance effect occurring below 400 Hz which at this stage cannot be modelled by the SIPS.

**FSTC Failure Due To Incorrect Suspension System**

- ▲ Measured On Site - FSTC 45 (hard ceiling suspension system)
- INSUL Predicted - STC 42 (solid suspension system)
- INSUL Predicted - STC 57 (GBSCA 60a)

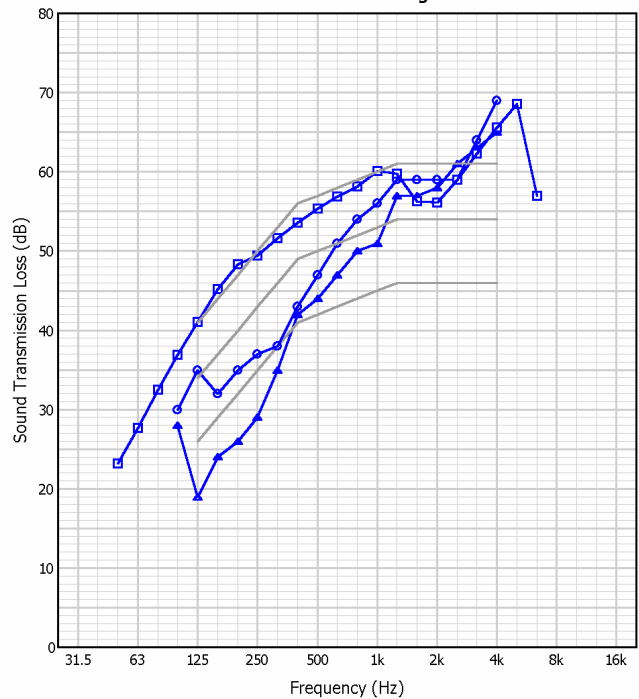
**Figure 8B: Timber Floor and Ceiling  
Gib GBSCA 60a - STC 58**

**FSTC Failure and Rebuilt Ceiling Test Results**

- ▲ Measured On Site - FSTC 42 (hard ceiling suspension system)
- Measured On Site - FSTC 50 (rebuilt ceiling system to GBSCA 60a)
- INSUL Predicted - STC 57 (GBSCA 60a)

The results of another floor/ceiling system in the building is also shown in Figure 8B, before and after rectification works, which showed an improvement from FSTC 42 to FSTC 50 following installation of the correct resilient suspension system as specified by Gib.
